Navajo Abandoned Uranium Mine

Site Screen Report

Jack Huskon No. 3 AUM Site

Weston Solutions, Inc.

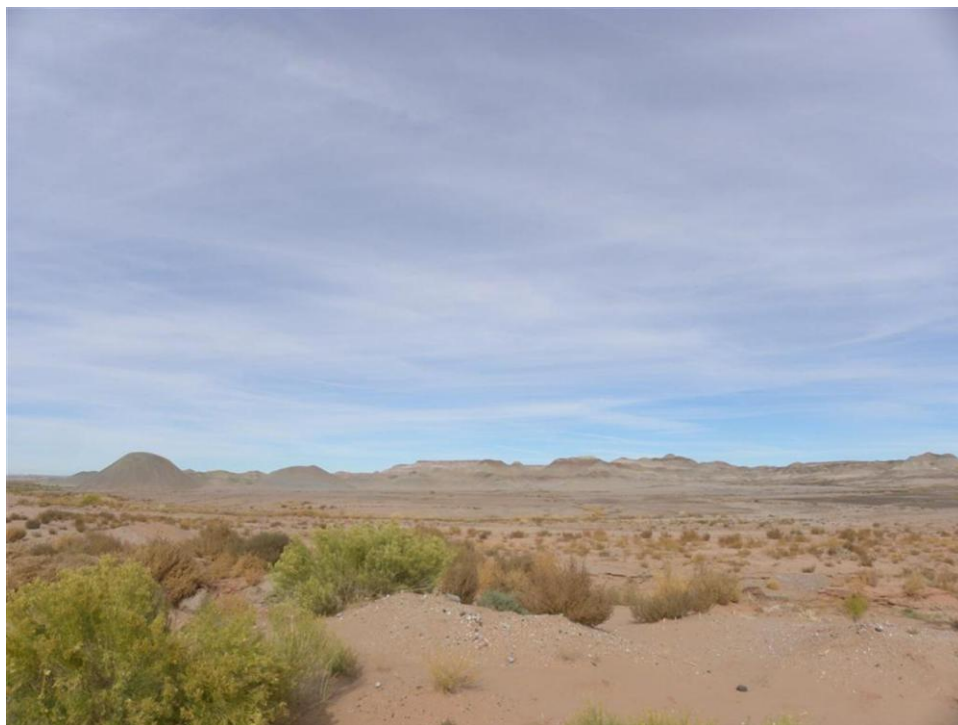
Photo 1. Jack Huskon No. 3 mine site

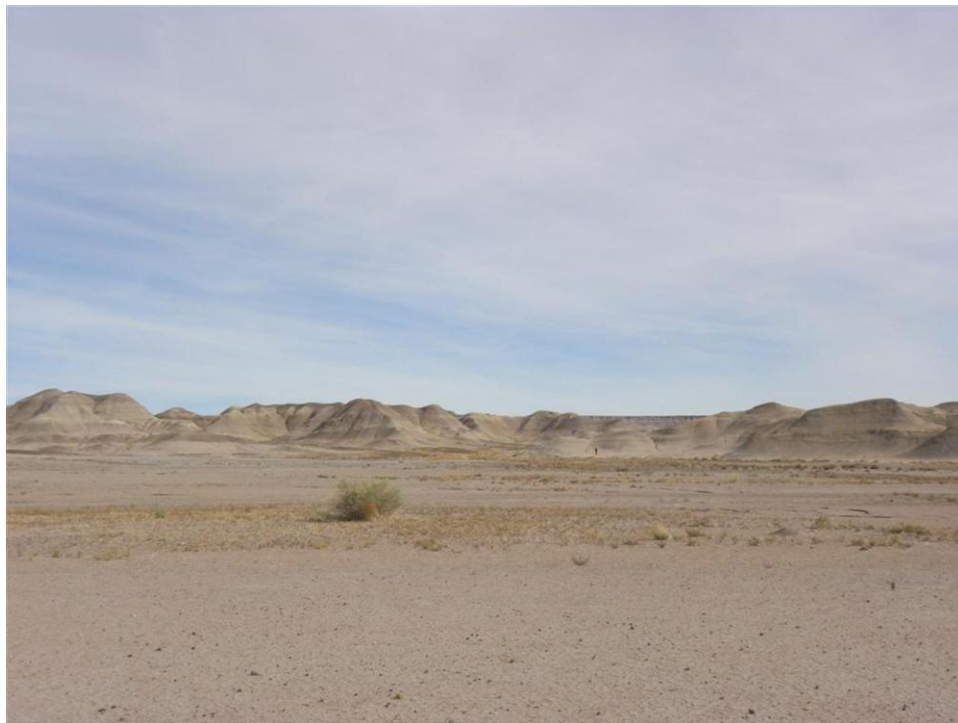
Photo 2. Jack Huskon No. 3 mine site

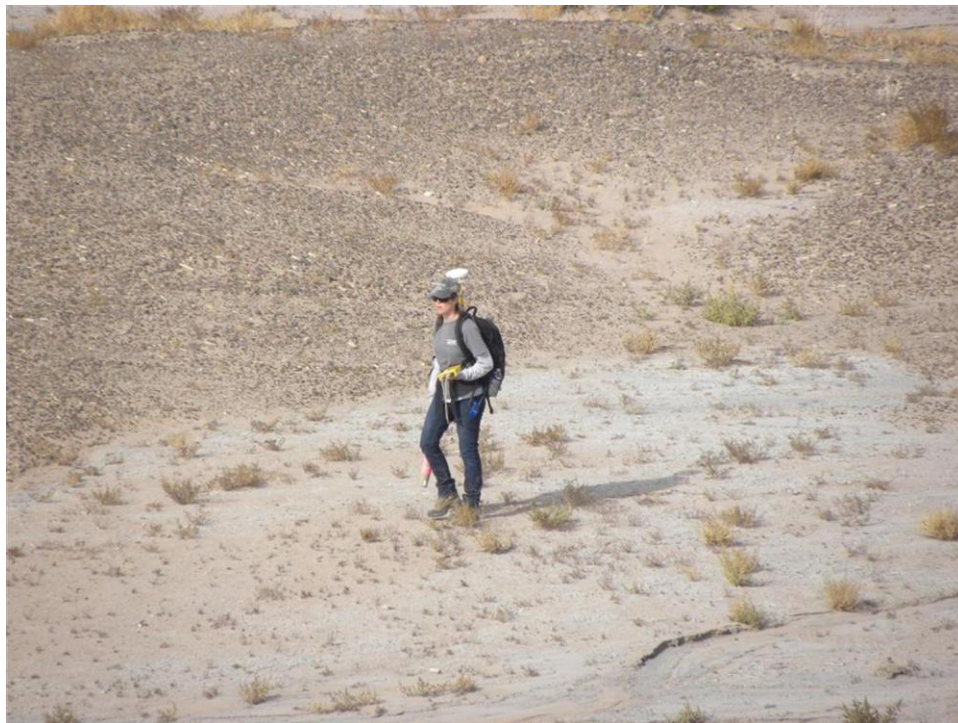
Photo 3. Jack Huskon No. 3 mine site, collecting readings

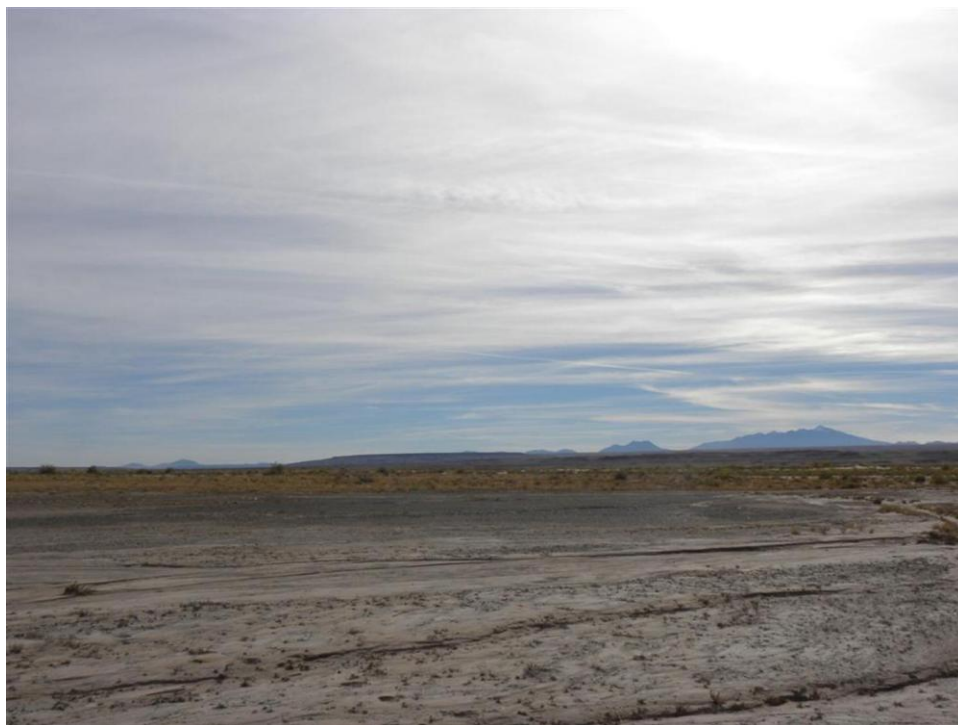
Darkened soil over the area identified as "Open Pit Mine" on topo map, no visual evidence of pit

Photo 4. Jack Huskon No. 3 mine site, darkened soil, possible former pit area

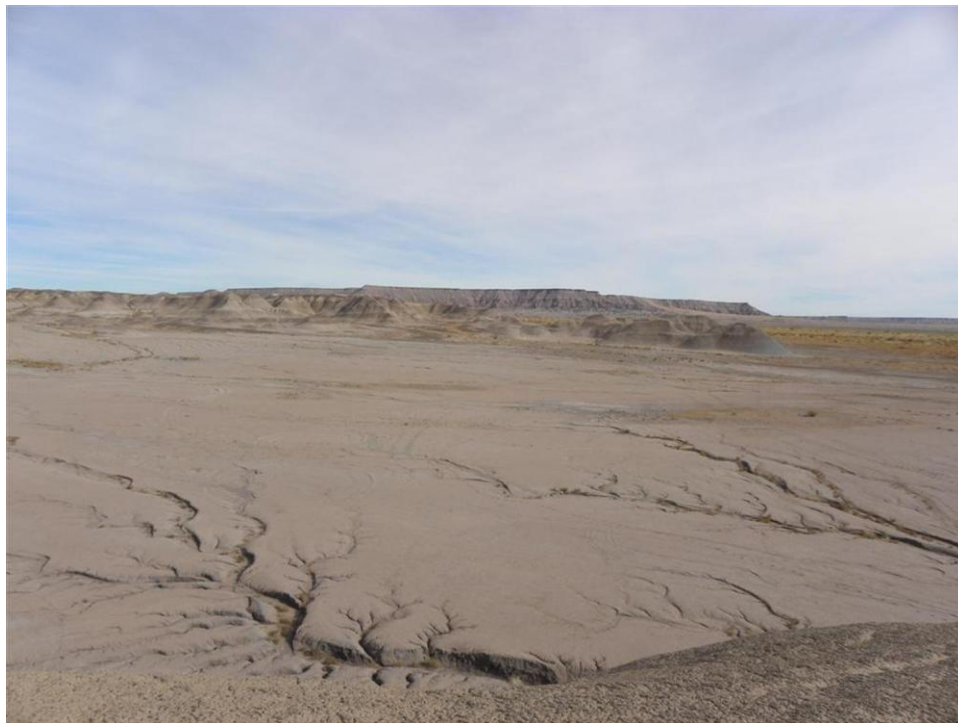
Photo 5. Jack Huskon No. 3 mine site, onsite drainage paths

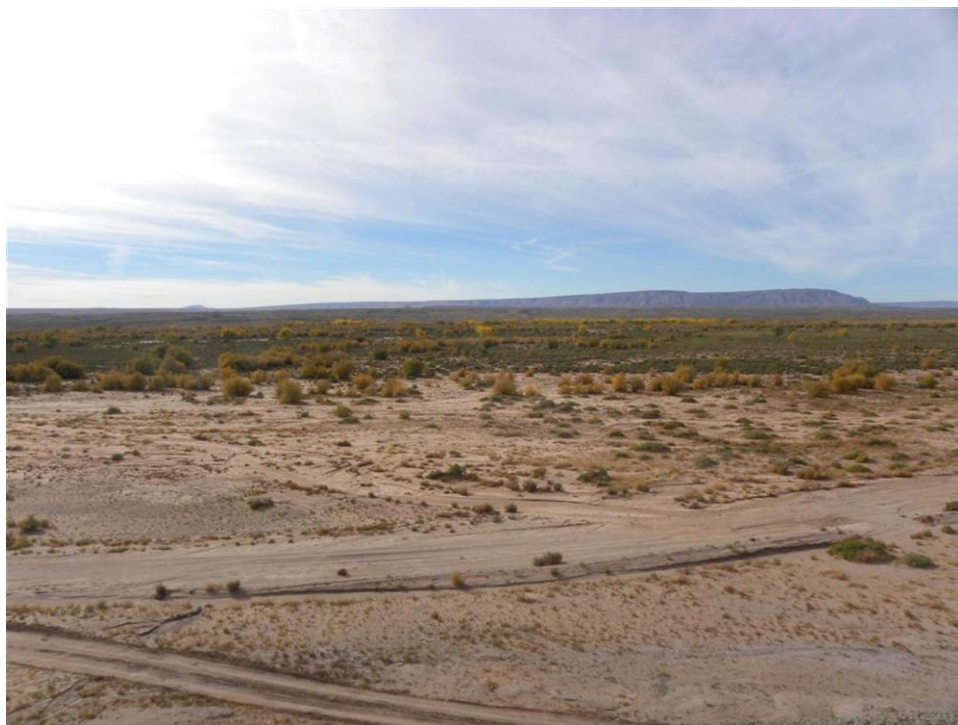
Photo 6. Jack Huskon No. 3 mine site, western road area and river basin

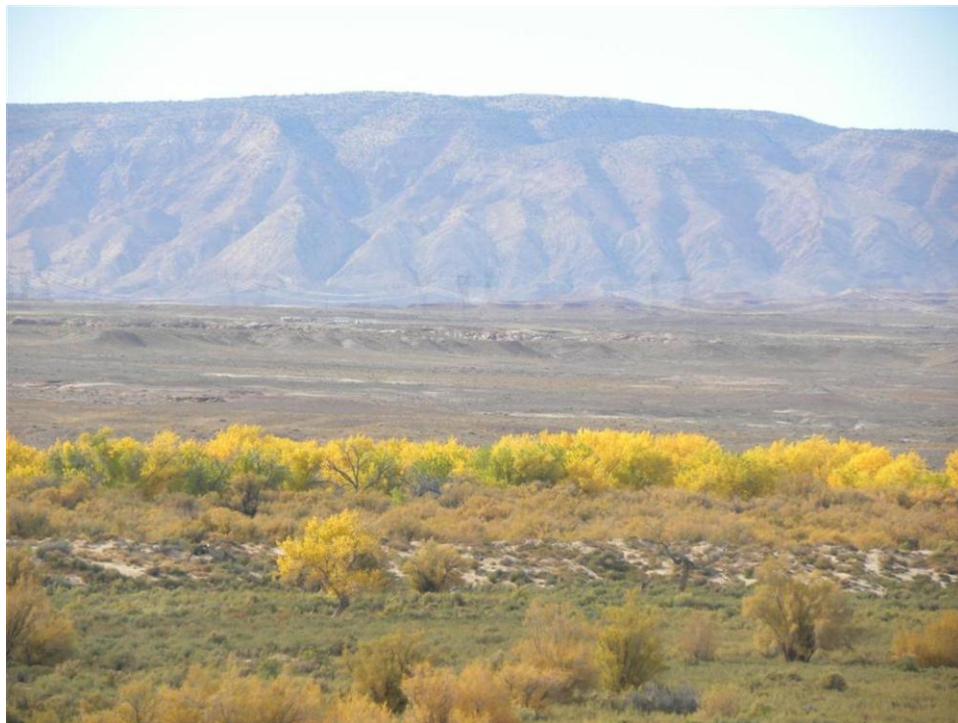
0.25 miles to 4 miles: Windmill Well approximately 1.5 mi NW of the site; Little Colorado River Basin approximately 1 mi W of the site

Photo 7. Jack Huskon No. 3 mine site, Little Colorado River basin to the west
